CULTURAL RESOURCE EVALUATION, TARGHEE NATIONAL FOREST
ADMINISTRATIVE SITES OF THE CIVILIAN CONSERVATION CORPS ERA

James A. McDonald
Forest Archaeologist

TG83-122
Targhee National Forest
St. Anthony, Idaho

February 10, 1983

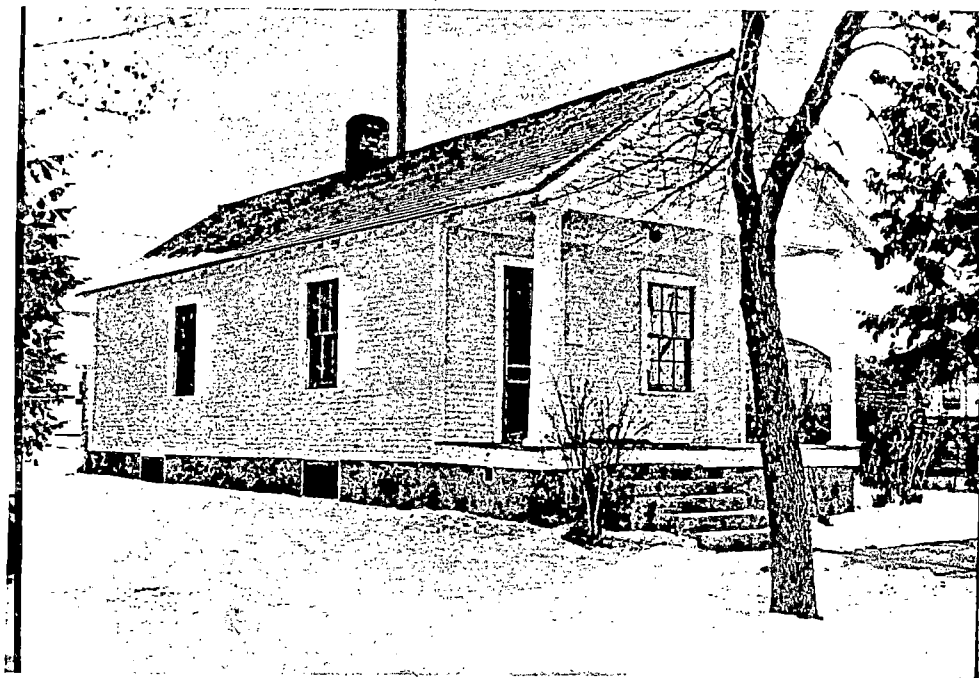
Figure 1: Ashton R.S. Office, before enlargement.

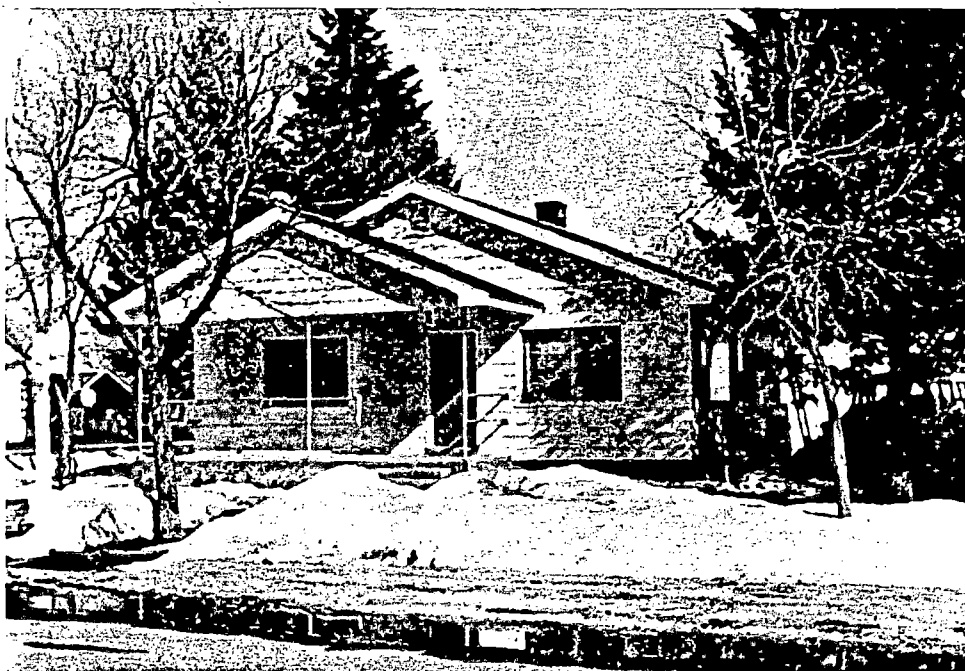
Present Condition: The office was enlarged by the addition of two rooms in 1962, and in 1972 was converted to a bunk house (a sink, shower and stove were installed). The other buildings remain on the site and are largely in their original condition (they have been repaired, and other maintenance conducted, but still conform to the original plans). A cinder block pesticide storage building was constructed in the compound in 1978 or 1979.

Figure 2: Ashton R.S. Office, after enlargement and conversion for use as a bunkhouse.

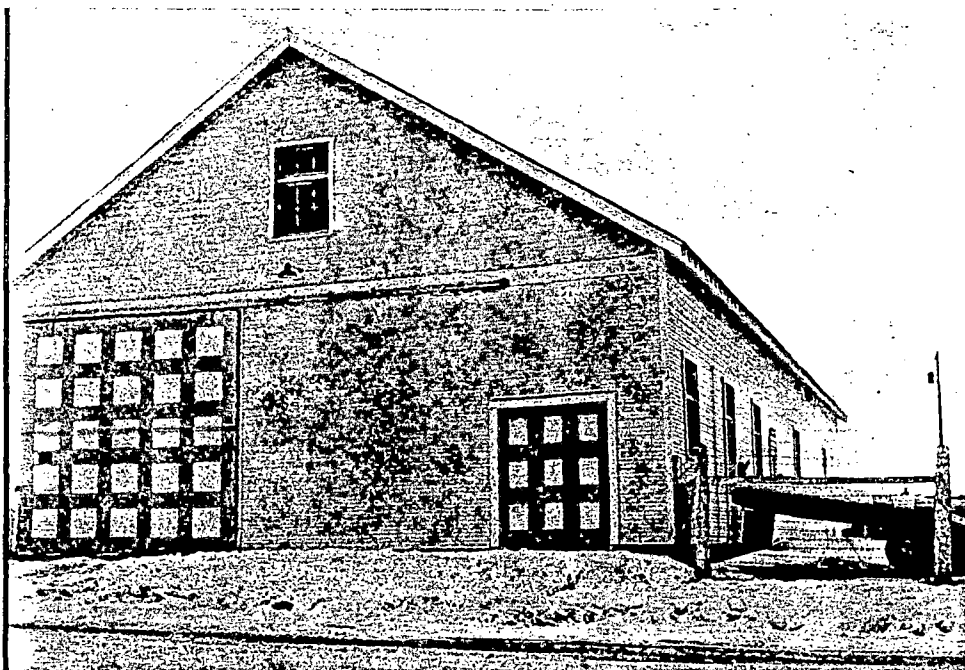
Figure 3: Ashton R.S. equipment shed and warehouse.

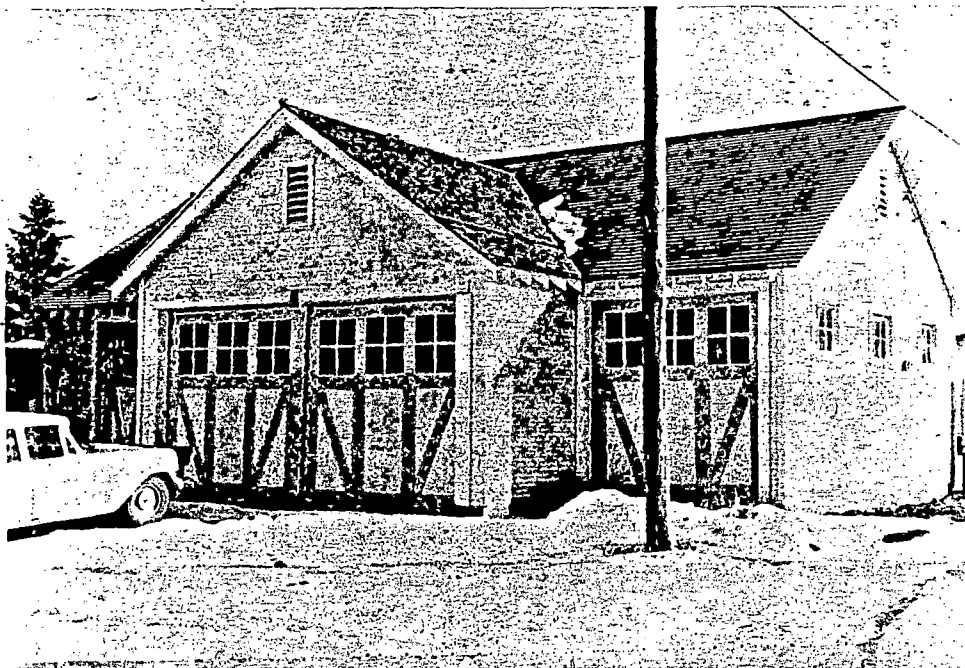
Figure 4: Ashton R.S. shop and garage.

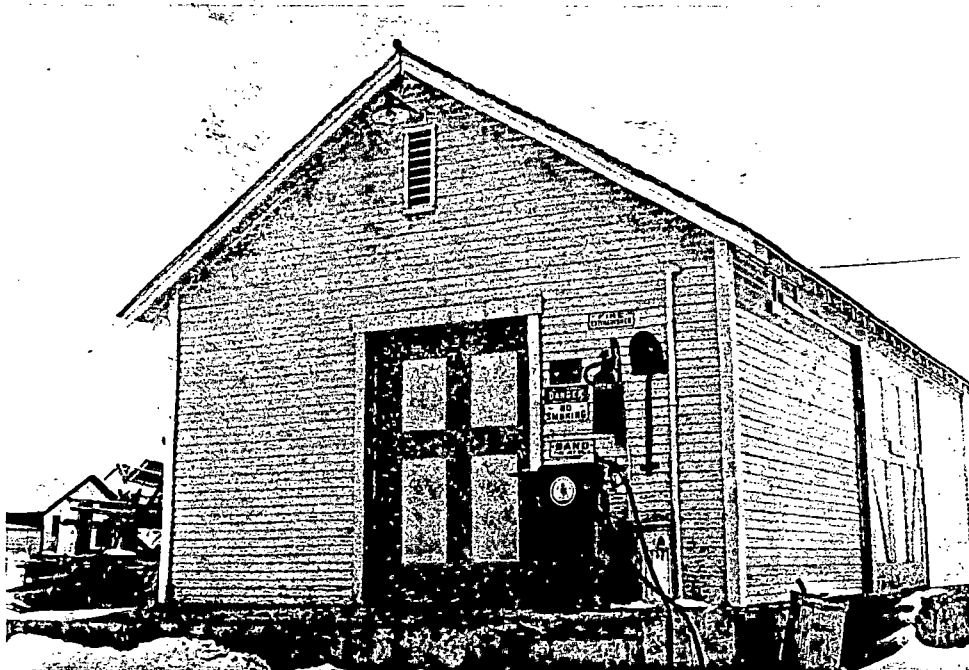
Figure 5: Ashton R.S. gas and oil house.

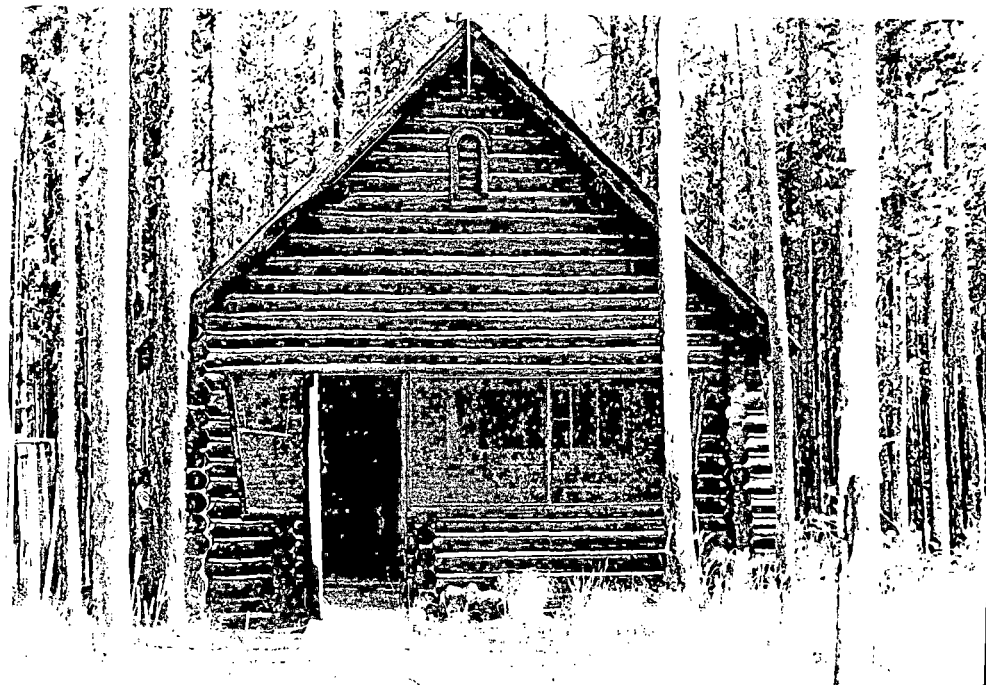
Present Condition: All buildings are standing and in their original location. Their structures are sound. However, the lookout complex has been unused and unmaintained since 1972. Extensive vandalism has occurred - most windows are broken and one sash from the tower cab has been pulled out and dropped to the ground.

Figure 6: Big Springs L.O. cabin.

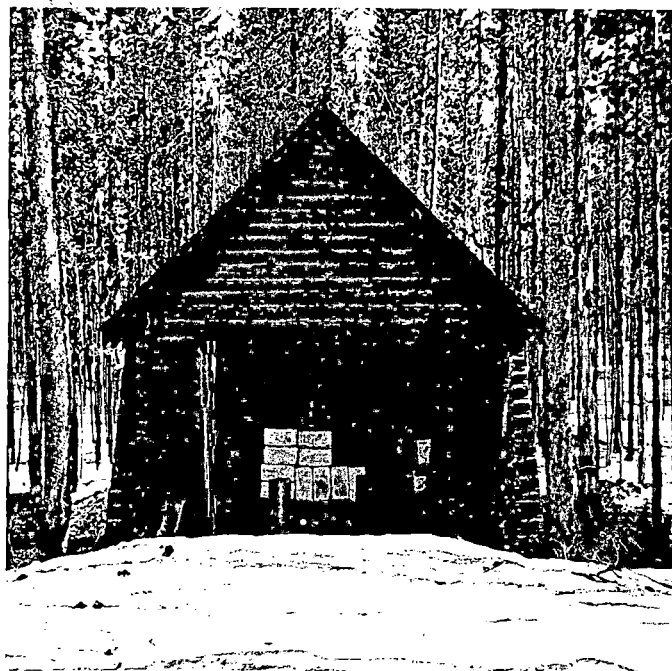
Figure 7: Big Springs L.O. garage.

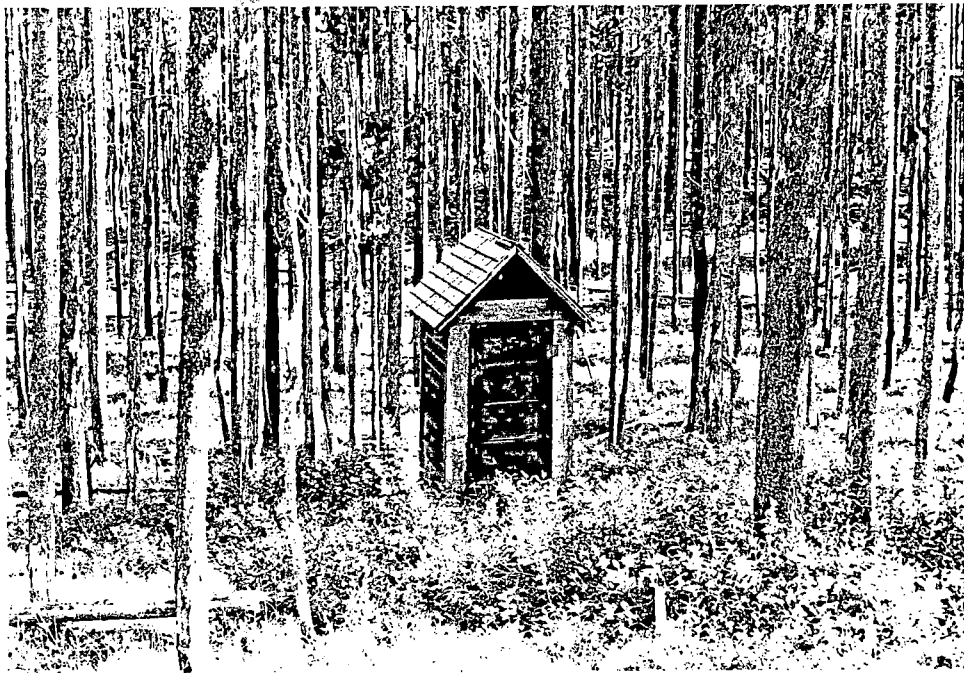
Figure 8: Big Springs L.O. toilet - a typical
plan R4-70.

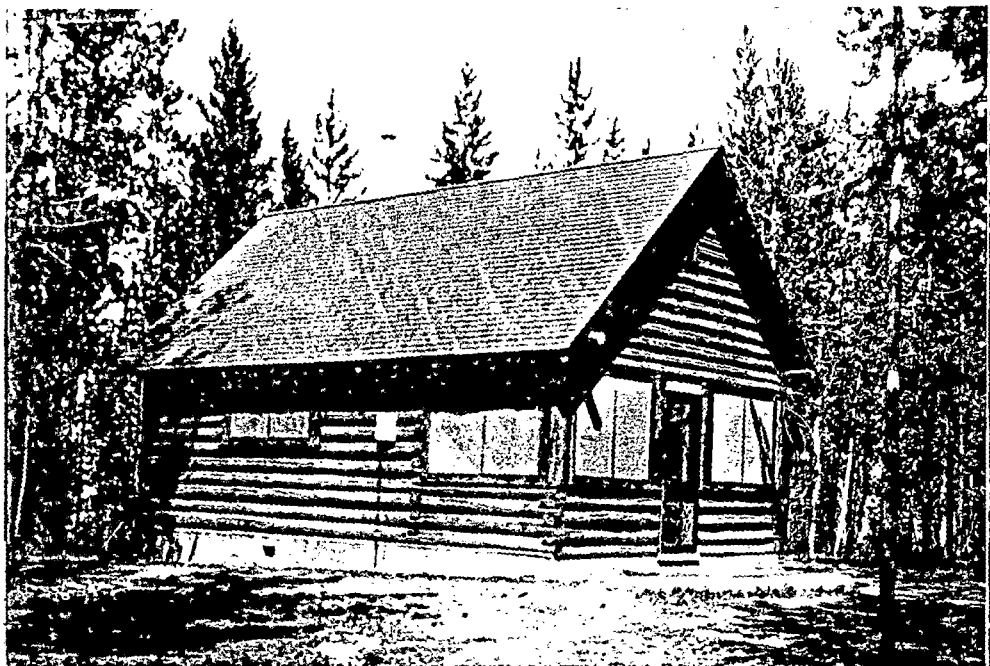
Figure 9: Bishop Mountain L.O. cabin.

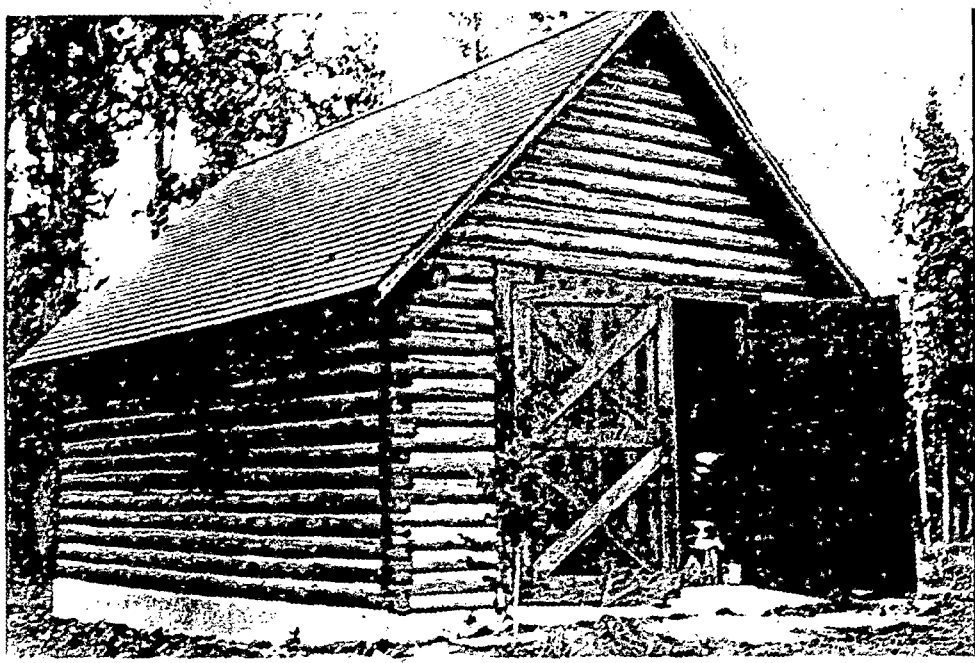
Present Condition: All buildings have been minimally modified and conform to the original plans. The garage roof is beginning to collapse, however, and requires immediate repair. The setting has not been modified.

Figure 10: Bishop Mountain L.O. garage.

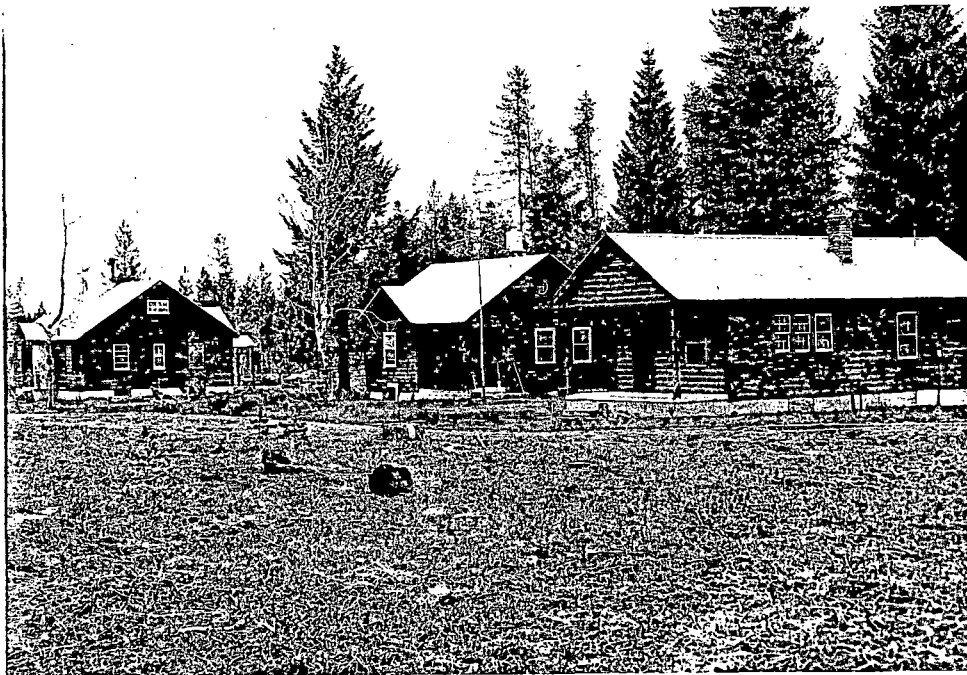
Figure 11: Buffalo (now Island Park) R.S., looking approximately NE and showing, from the left, the 1940 dwelling, the 1936 dwelling, and the 1936 office.

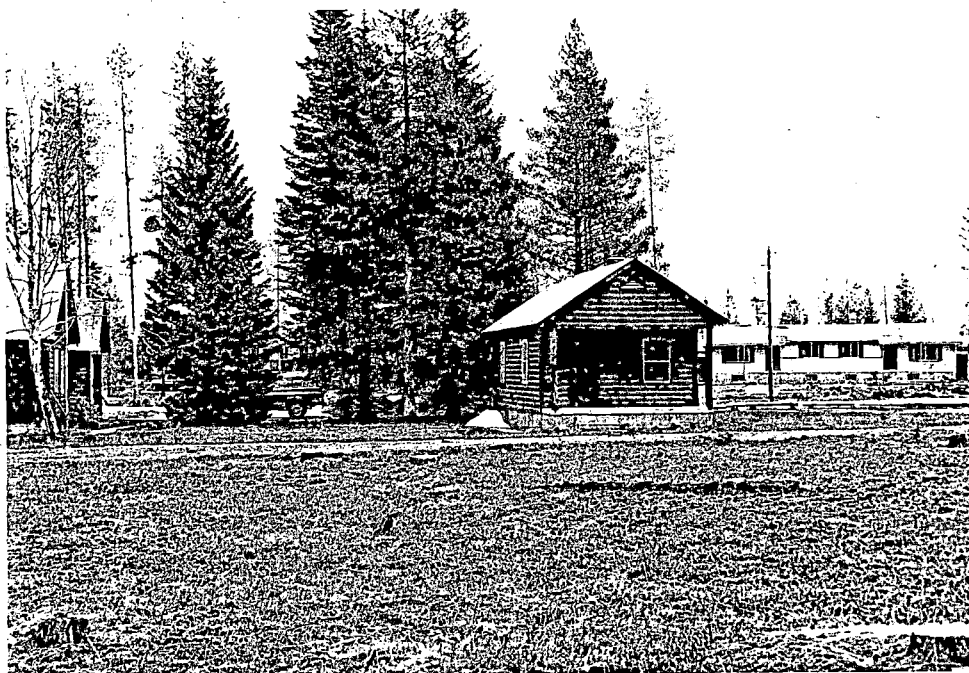
Figure 12: Buffalo (now Island Park) R.S., looking approximately SE and showing, from the left, the 1936 dwelling, the garage (behind the dwelling), the office, and a 1981 duplex.

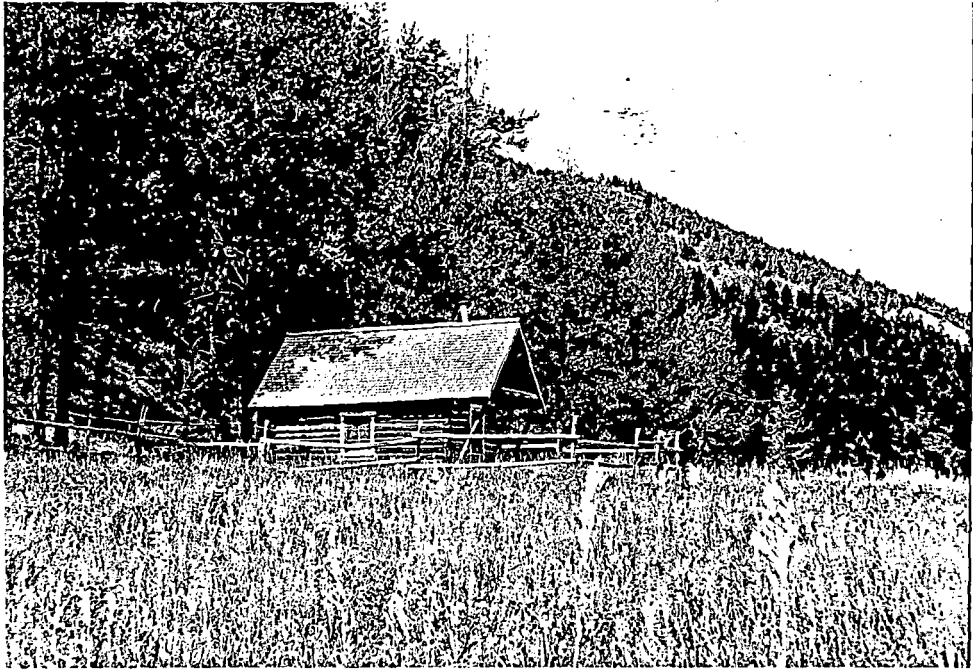
Physical Appearance: The cabin is of log construction, 12' wide and 14' long (including a 4' front porch). It has two windows and a shingle roof. The foundation and floor of the cabin are concrete. There is an open toilet. The site is remote, and stands at the edge of a mixed conifer forest along Bear Creek.

Present Condition: The Station is in good repair, with no recent modifications. Because of its remoteness, this site was not visited for the purposes of this survey.

Figure 18: Currant Creek G.S.

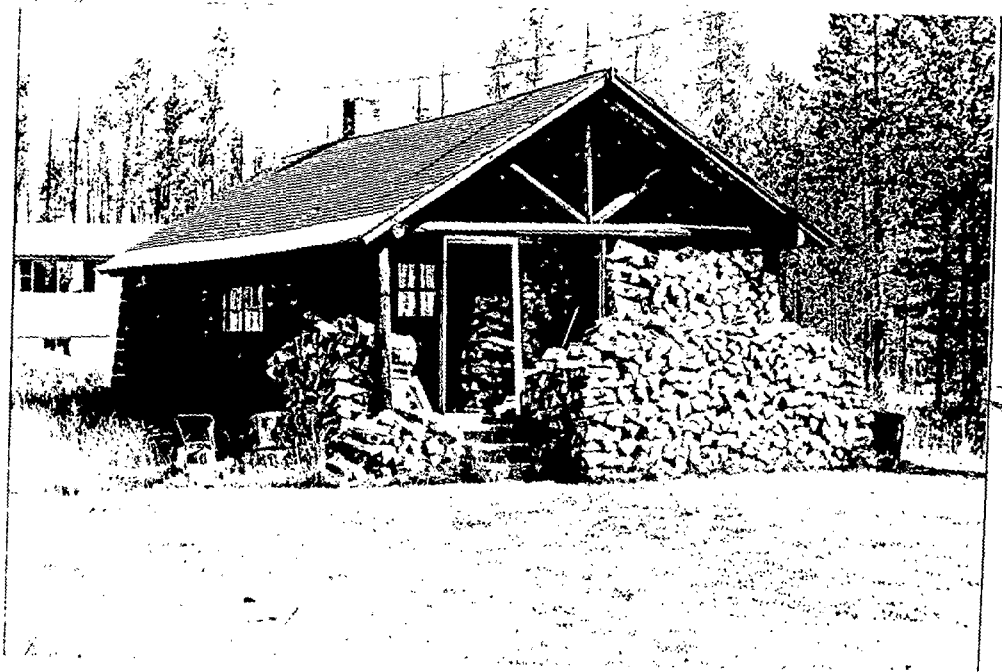
Present Condition: There are no buildings remaining at the administrative site. The cabin is structurally sound and is maintained, but its integrity of location has been lost through the move, and the integrity of feeling and association have been lost as a result of the change in function.

Figure 19: Former Flat Rock Guard Cabin, shown after movement to the Island Park R.S.

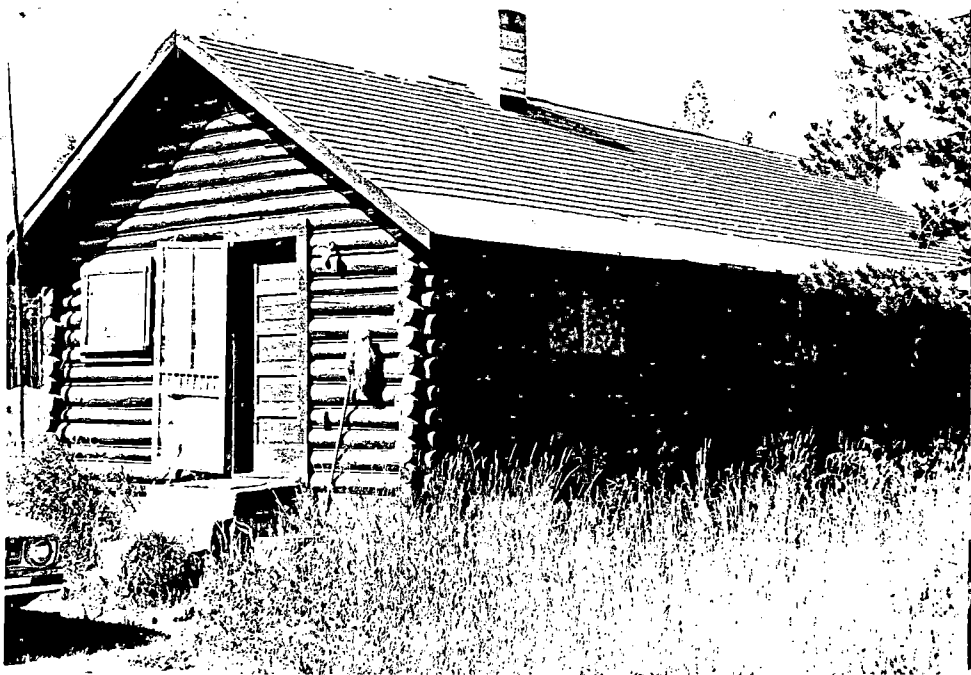
Figure 20: Guild Scaler's Cabin, shown after movement to
Island Park R.S.

Present Condition: The cabin and garage were moved to the Island Park Ranger Station, and have since been dismantled.

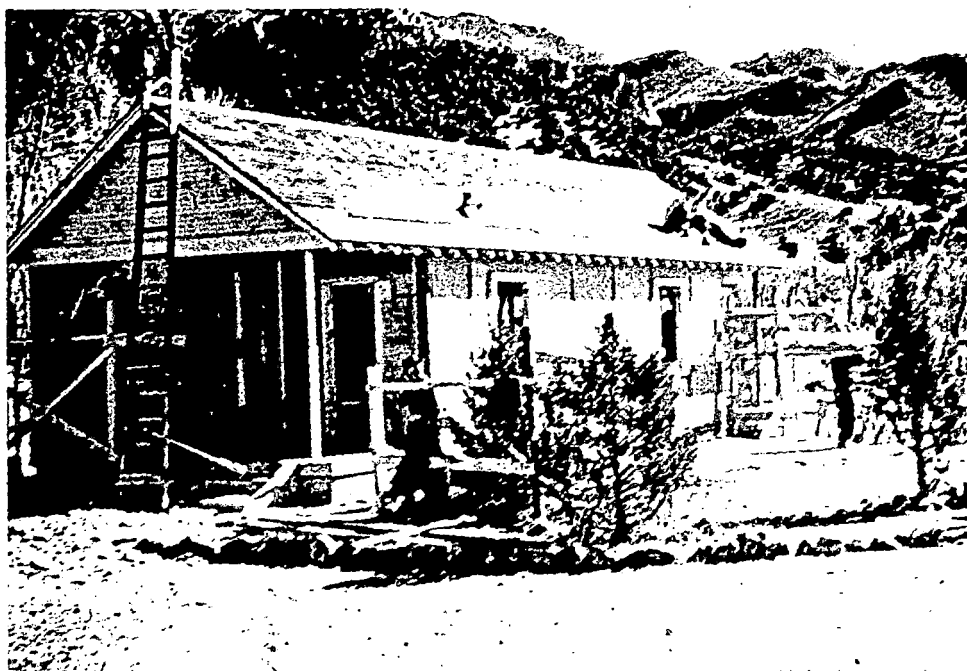
Figure 24: Heise R.S. office under construction, looking at back porch.

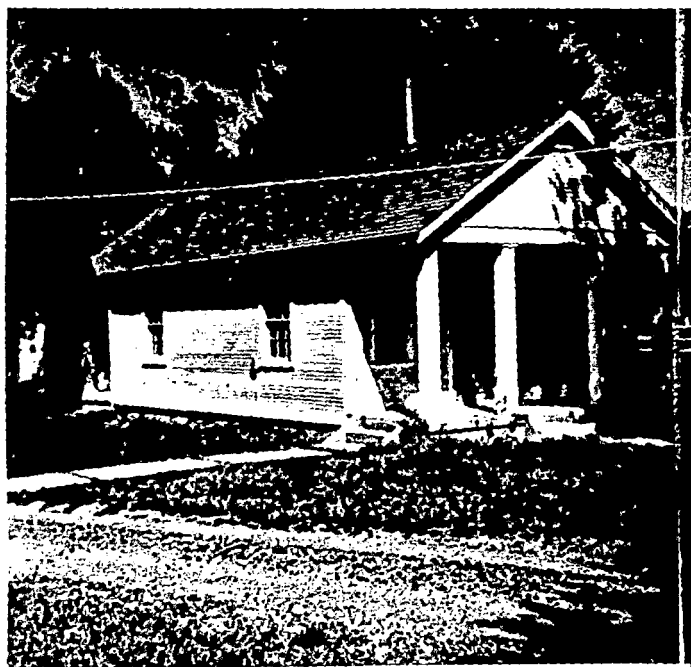
Present Condition: The station is seldom used and there has been a lack of routine maintenance. However, the structures are still sound, and there have been no additions or deletions to the facilities (except for the above-mentioned outhouse).

Figure 25: Heise R.S. office, present appearance, looking at the front porch.

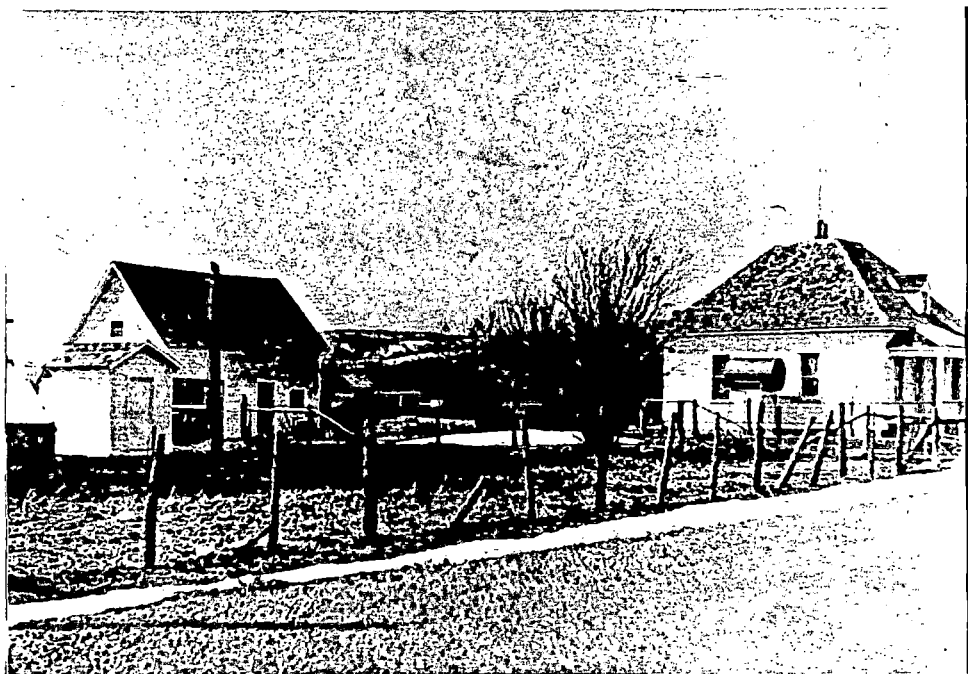
Present Condition: The integrity of this administrative site is poor. It consists of a mix of buildings of different ages, one of which was moved from its original location. It lacks a key component of the 1930's complex - the dwelling.

Figure 34: Kilgore R.S., showing, from left, the pumphouse, barn and dwelling.

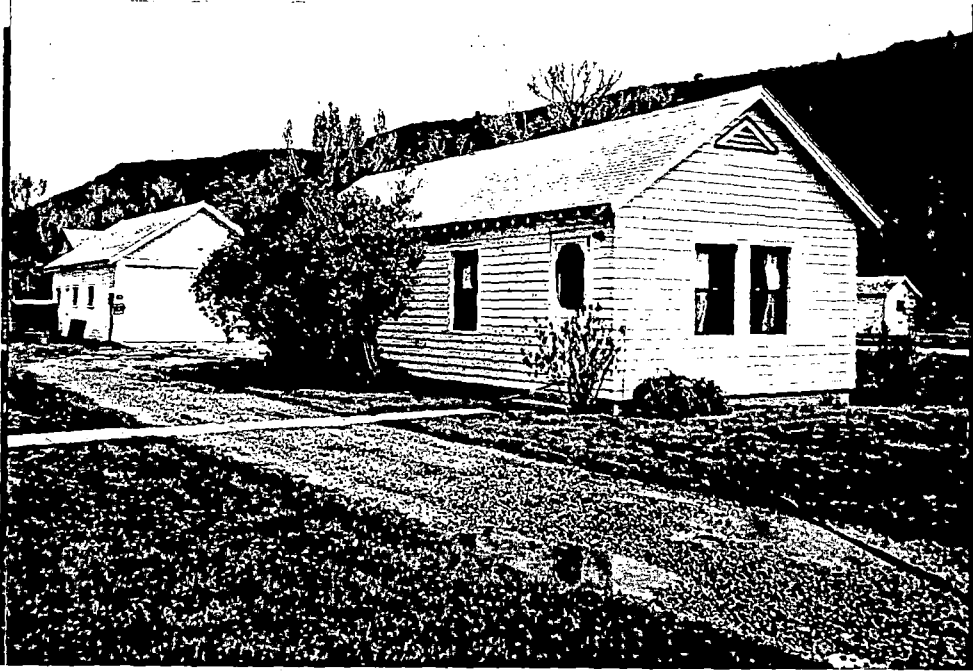
Present Condition: The dwelling largely retains the exterior and interior features of the 1930's. The office has been extensively remodeled to convert it to a bunkhouse: the porches were completely enclosed, a kitchen added, a shower, linoleum, carpeting, and paneling installed, and the clapboard siding added. The exterior of the barn retains its 1930's features, but the interior has been heavily modified: it now has no stalls, and has a tack room occupying a third of the ground floor. Likewise, the exterior of the equipment shed retains its 1930's features but the interior has been heavily modified. The upstairs storage area has been enlarged by placing a ceiling/floor throughout the building, and the walls have been insulated and covered with plywood. The garage is now used as a fire equipment cache. The interior has been remodeled to create additional shelving and storage bins. Its exterior is essentially unchanged since the 1930's. The woodshed has been extensively modified on the exterior and interior: an addition was made to the back in 1957 that more than doubled its size. The front (the original woodshed) then became the station office. It was refinished on the interior with paneling. The addition is used as a pumphouse and storeroom. The gas house originally had a double door on its front. One of the doors panels has been removed and replaced with a piece of plywood. The toilet is no longer used. It has been moved from its original location and is now in a poor state of repair. No trace of the icehouse remains. An open hay shelter has been added to the station, and a steel radio tower installed. Lastly, the access road from the highway has been realigned.

Figure 41: Snake River R.S. office, now used as a bunkhouse. The garage is visible in the left background.

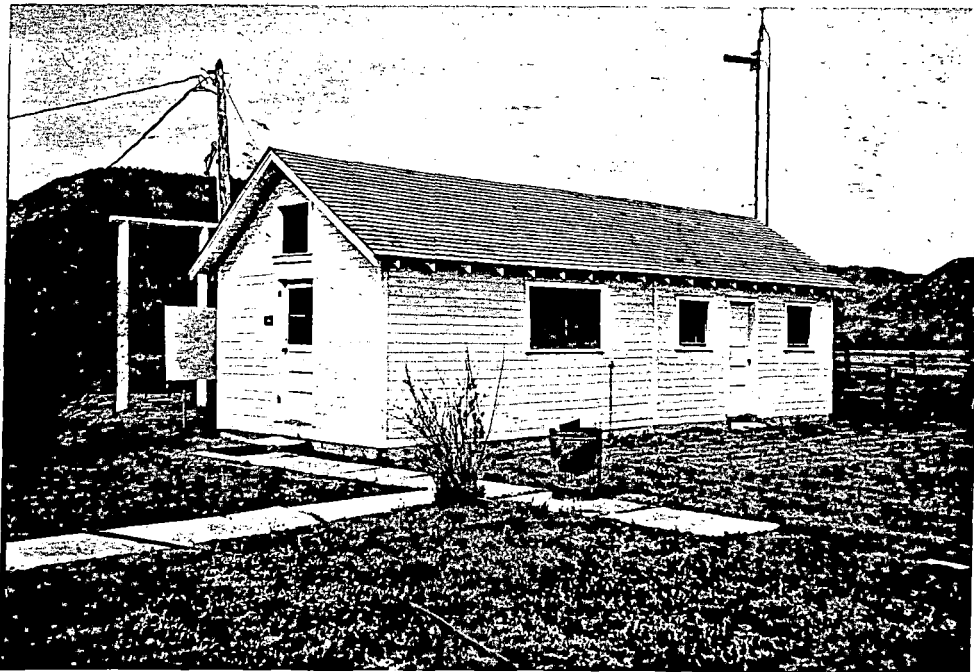
Figure 46: Snake River R.S. woodshed (left half), now used as an office, with added pumphouse on the right side.

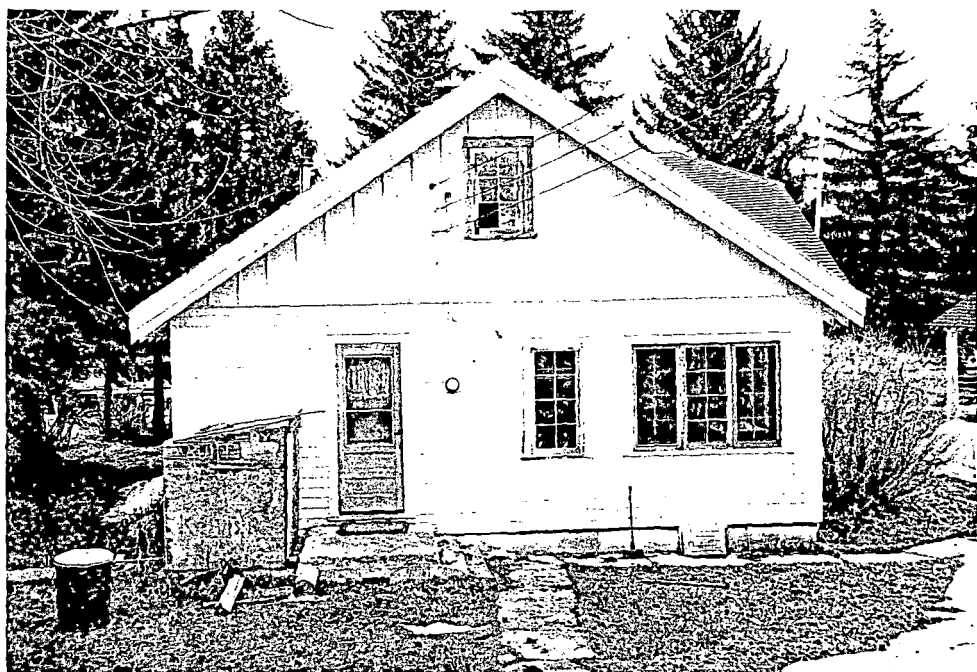
Present Condition: The dwelling was remodeled in 1948 and 1958, but a copy of the 1934 construction plans is available, so that the C.C.C.-era appearance can be reconstructed. The office has been slightly damaged by fire, but again a copy of the original standard plan is available. The barn and equipment shed retain their original appearance but are suffering from lack of maintenance. Removal of the garage constitutes a minor loss of integrity, since the overall scale and appearance of a 1930's Ranger Station is retained. Nearby buildings in Spencer are generally of the same age as the site, and integrity of setting, feeling and association has been retained.

Figure 49: Spencer R.S., rear of dwelling.

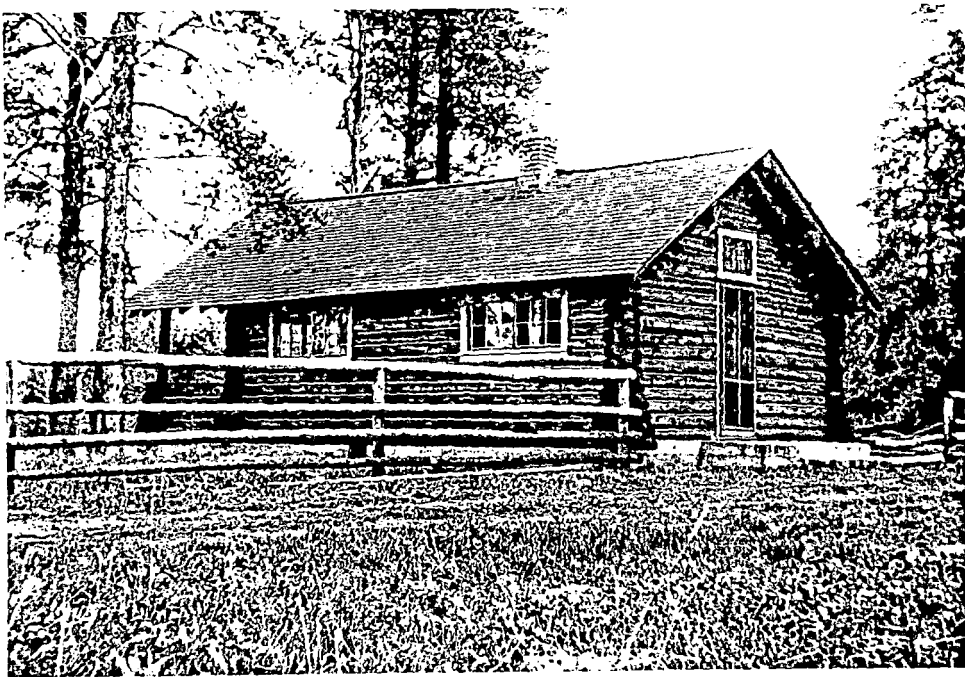
Physical Appearance: No information is available on the appearance of the original cabin. The 1934 cabin is a two-room log cabin with an enclosed porch. The cabin is stained brown with green trim on the window frames. The original finish was linseed base stain on natural logs with gray trim. It has a gable, light green steel roof over shingles. There is a finished ceiling, but the interior walls are log. There is also a wood-frame outhouse, construction date unknown, built to a plan R4-70.

Present Condition: The buildings are maintained and in fair to good condition. The porch has recently been screened in. There is a large, white propane tank next to the cabin that constitutes a significant visual intrusion. A hand pump well was drilled adjacent to the cabin in 1981.

Figure 53: Squirrel Meadows G.S., photographed in the 1950's.

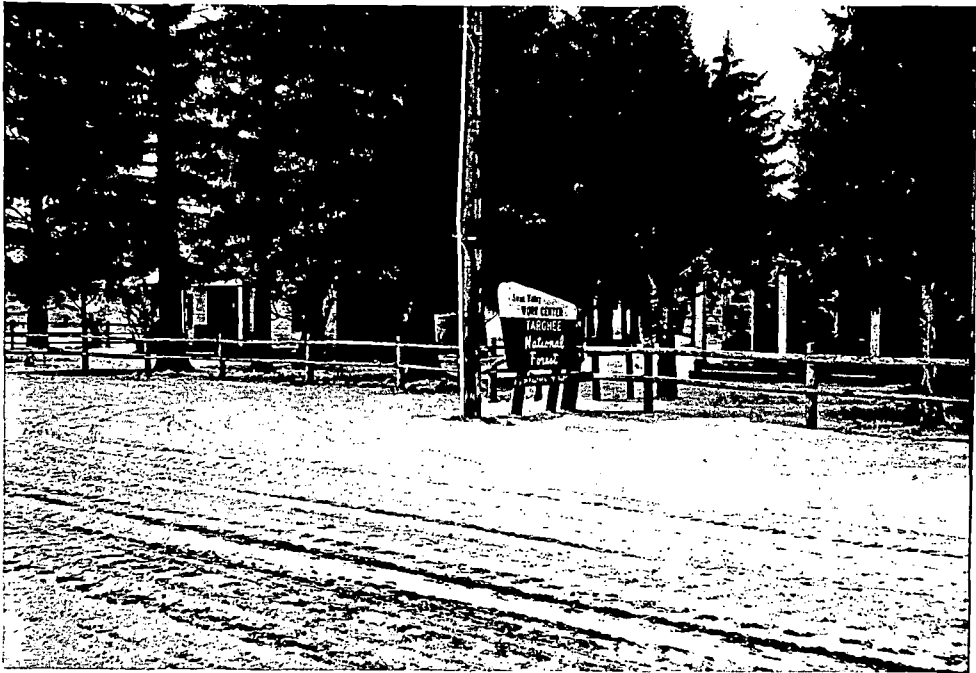
Present Condition: The details of this administrative site's setting and building interiors have been heavily modified. Two bunkhouses have been added to the site, one moved in from Alpine in 1949 and another a converted tool shed moved in from Victor in 1956. Both are in keeping with the architectural style of the original site - they are rectangular one-story buildings with white shiplap siding and gable roofs. They do expand the scale of the station, however. Less in keeping with the original architecture of the station, is a one-story wood-frame duplex with white aluminum clapboard-style siding and a gable roof, constructed in 1980. This also expands the scale of the station. Other additions to the site consist of a seed storage building and a pumphouse.

Original interiors of several of the important buildings have been extensively remodeled. The dwelling has been insulated, sheet-rocked and paneled, and new doors and floor coverings have been installed. The bathroom of the office has been remodeled and the front porch replaced (although it is quite similar in appearance to the original porch). The former garage has been insulated and new shelving installed. The equipment shed has had a ceiling installed, and the garage doors have been removed and replaced with a wall. New shelves, bins and cabinets have been placed in the barn. Modifications to the other original buildings have been limited (or unrecorded).

Figure 54: Swan Valley R.S., front view. The dwelling is on the left, the office on the right.
